3rd International Conference TMM_CH

«Protection of our cultural Heritage: Examination of bending issues during preservation of wall-paintings»

Angelos Ntaflos, Maria-Elissavet Kouli, Alexandra Papapavlou,
Christina Gioti, Maria Kosarli, Alkiviadis S. Paipetis

COMPOSITE AND SMART MATERIALS LABORATORY
(csmlab.materials.uoi.gr)

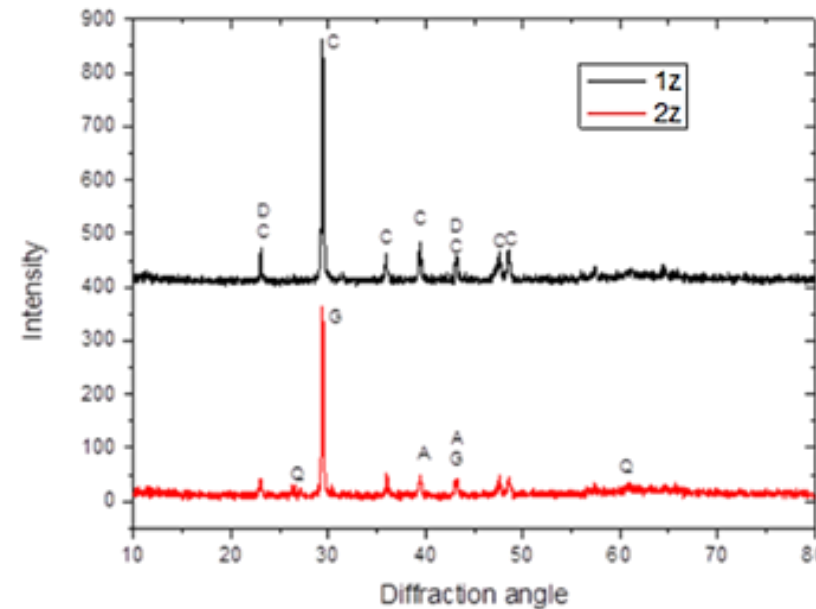
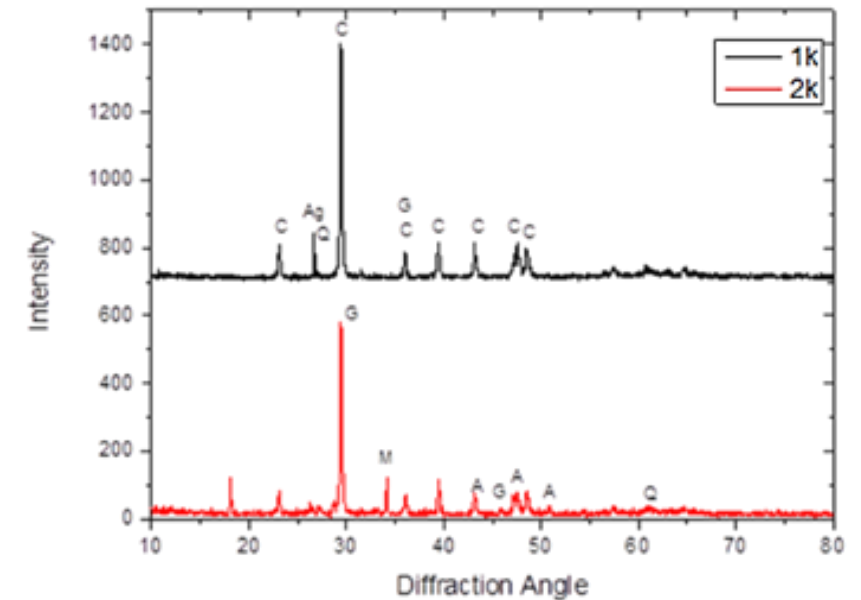
X-ray Diffraction (XRD)

- XRD results of the painting surface for paintings 1 and 2.
- C=Calcite, D=Dolomite, Q= Quartz, G=Gypsum, M=Manganite, Ag= Ag₂O₃, A=Aragonite.

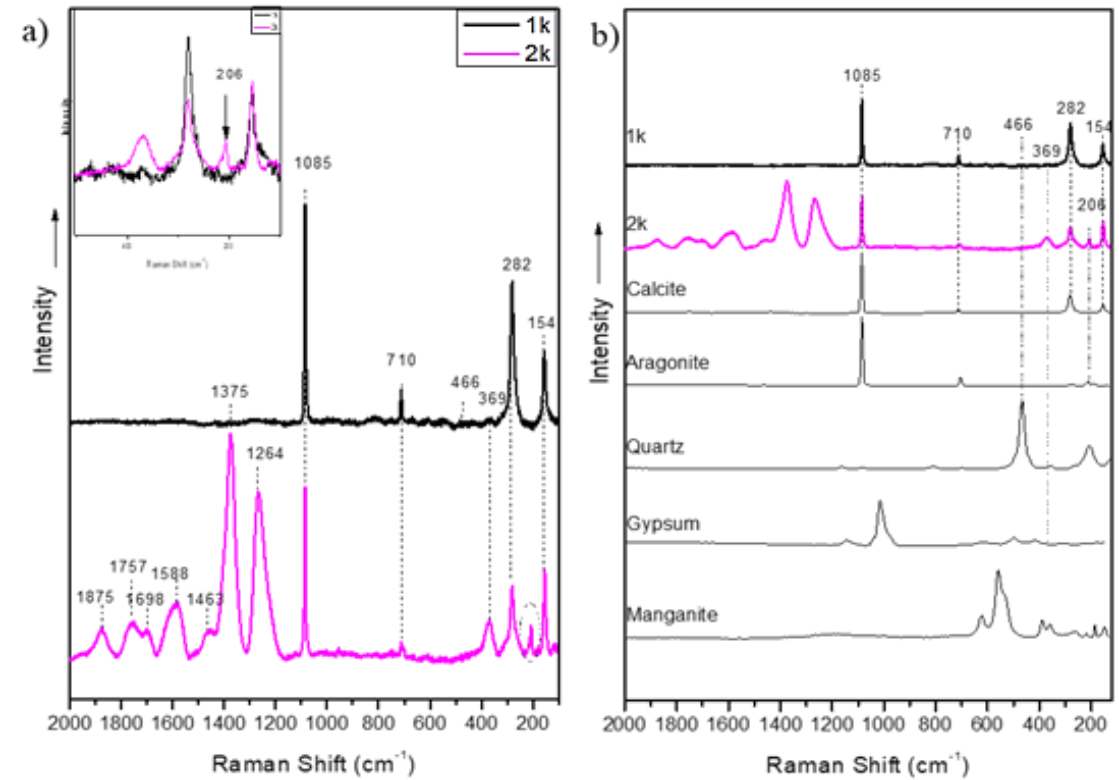
Raman Spectroscopy

- Raman Spectra of plaster substrate for paintings 1 and 2.
- Comparison of the Raman spectra to XRD results

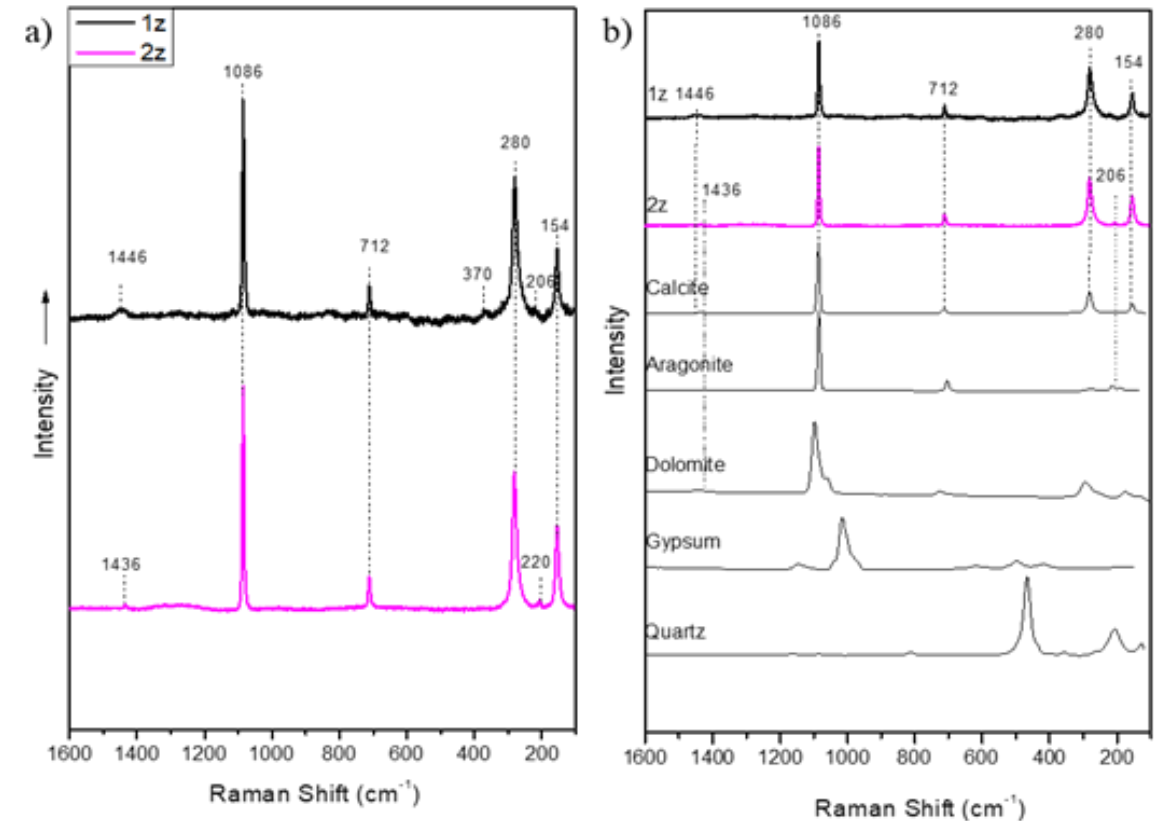
Raman Spectroscopy

- Raman Spectra of painting surface for paintings 1 and 2.
- Comparison of the Raman spectra to XRD results

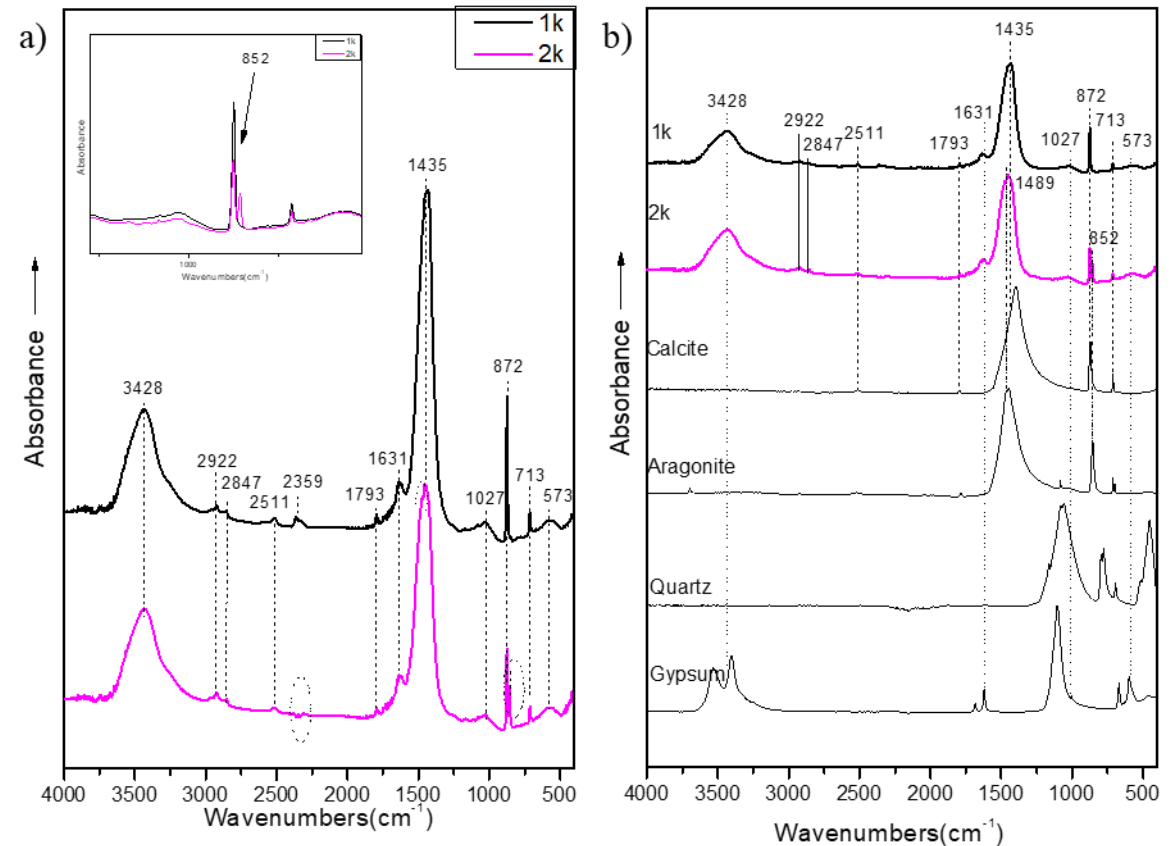
Fast Fourier Infrared Spectroscopy

- FTIR spectra of the plaster substrate.
- In agreement with Raman and XRD results.
- Presence of Aragonite and gypsum

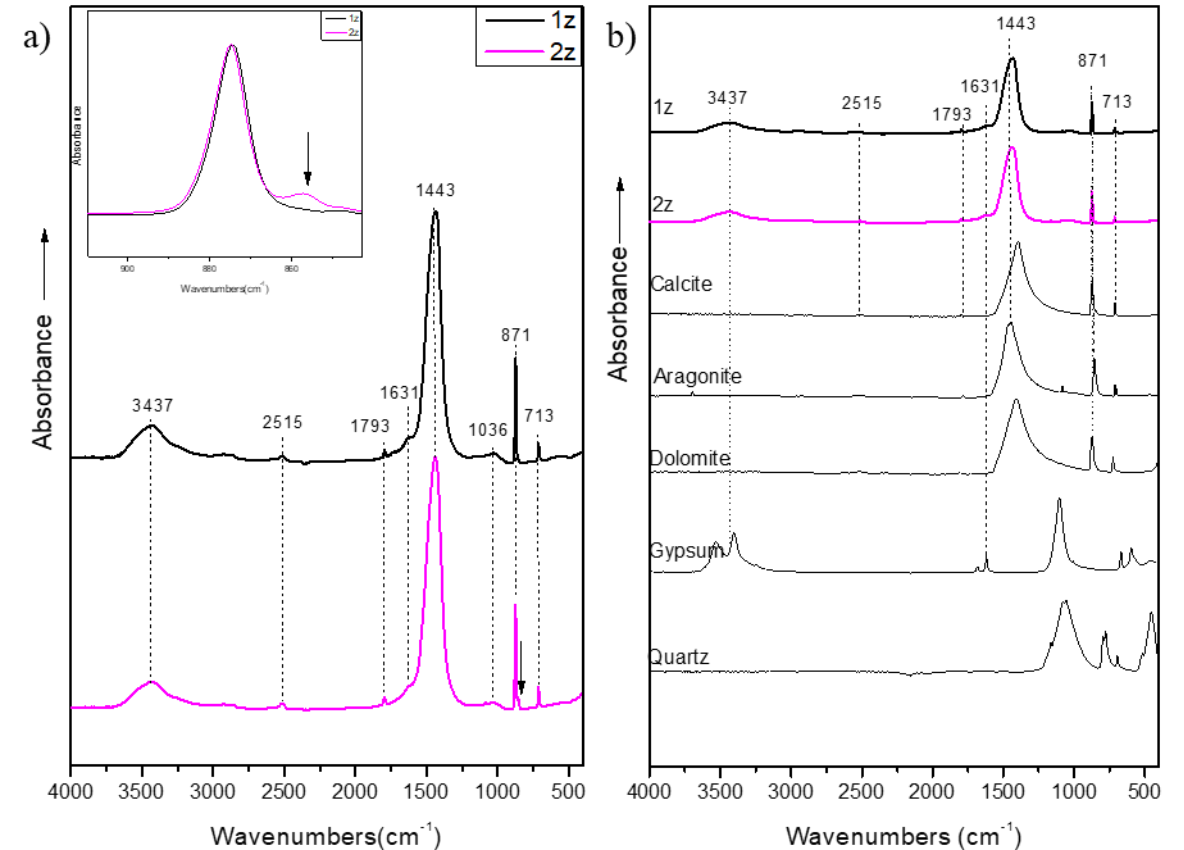
Fast Fourier Infrared Spectroscopy

- Mid-IR spectra of the painting surface
- In agreement with Raman and XRD results.
- Presence of Aragonite and gypsum

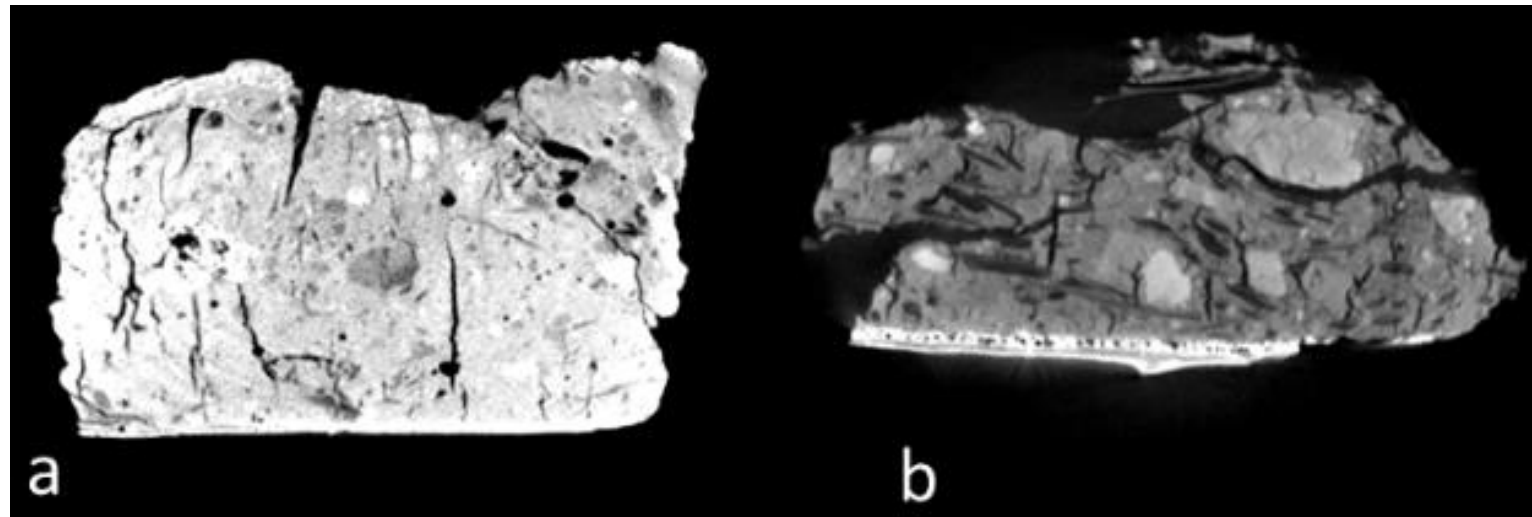
Micro-Computed Tomography

- Two samples containing the whole volume of the artefact were examined with uCT.
- Sample (a) was extracted from the defective wallpainting while Sample (b) from the reference wallpainting.

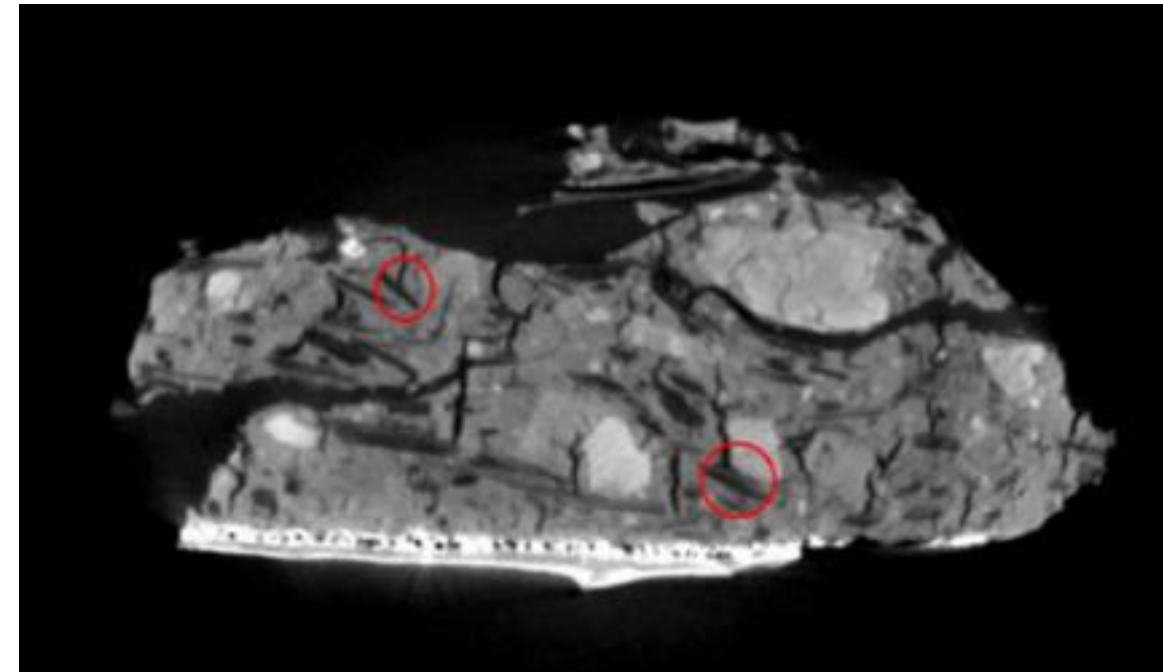
P1 sample. Total Area of ROI = 23 mm²

- P1 contains a reinforcing agent (straws).
- Higher porosity values exhibited as much as 22 %
- After immersion in an humidity chamber, no signs of water absorption were perceived.

- Vinavil and mortar were applied to consolidate and strengthen the initial substrate of the painting.
- The applied adhesion to P1 was successful due to the higher porosity.
- The addition of fibers in mortars contributes to volume stability.
- In contrast, P2 had low porosity due to its different microstructure. As observed by the preservation team the consolidant did not diffuse evenly into the substrate.
- Upon the hydration of the mortar/Vinavil mixture, the uneven distribution of the Primal caused differential strains at random sites and ultimately bending and microcracking.

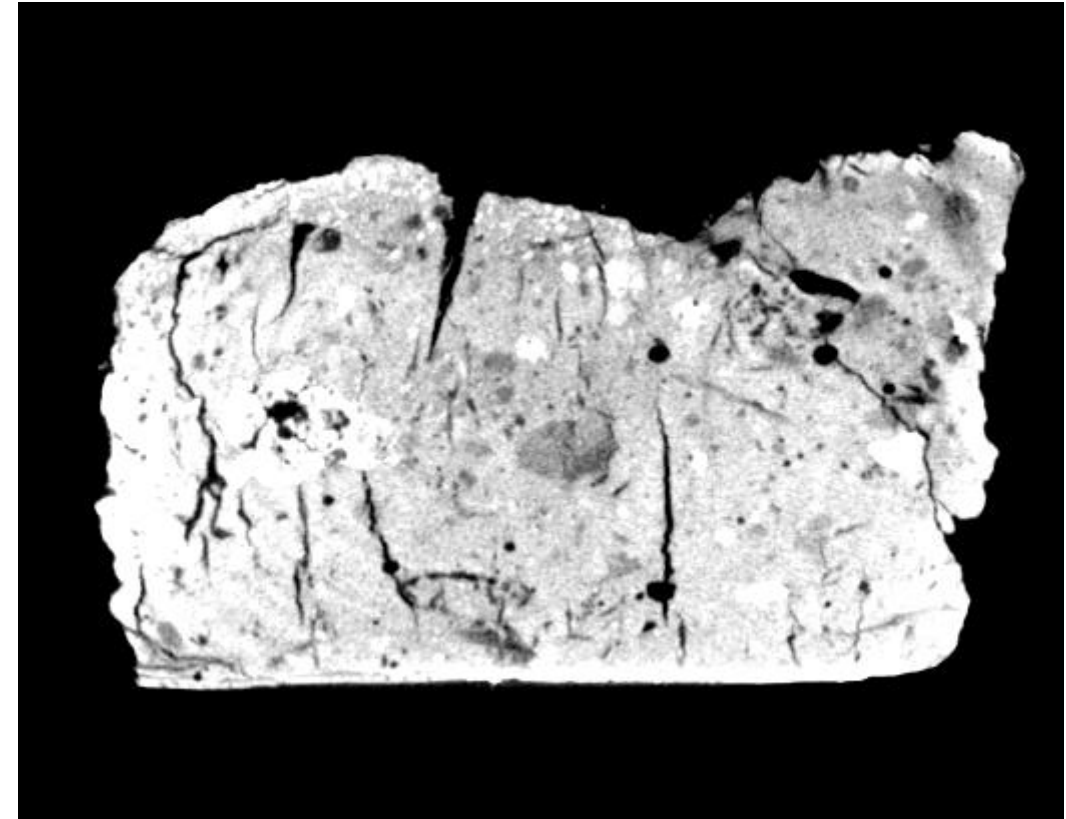
P2 sample. Total Area of ROI = 24 mm²

- P2 does not contain a reinforcing agent.
- Lower porosity values exhibited as much as 7 %
- After immersion in environmental chamber, no signs of water absorption were perceived.
